# 68060 ERRATA

Rev 4.0 - 10/18/96

## 060 Production Masksets

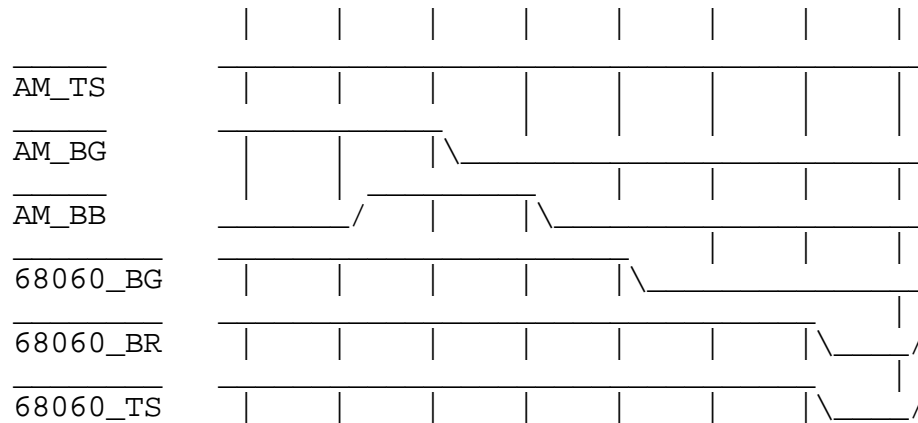
H4 - In systems with at least one alternate master which asserts only BB and not TS during bus tenure the 68060 may incorrectly take over bus mastership. This occurs if BG is asserted to both the alternate master and 060 where the alternate master had, at some time in the past, used the bus, relinquished the bus and started to use the bus again with no intervening bus cycles that assert TS. In this case, the 060 may run bus cycles if an internal request is pending without waiting for the alternate master to finish using the bus and negate BB.

The following timing diagram will illustrate this case.

Have the alternate master assert TS when it starts bus cycles

Assure that the bus grants to an alternate master and 68060 are mutually exclusive

Do not assert BG to the 68060 until the alternate master is done using the bus.
